AQUATIC RESOURCE STUDIES
CASCADE CREEK HYDROELECTRIC PROJECT
FERC NO. 12495-002

December 3, 2010

Cascade Creek, LLC

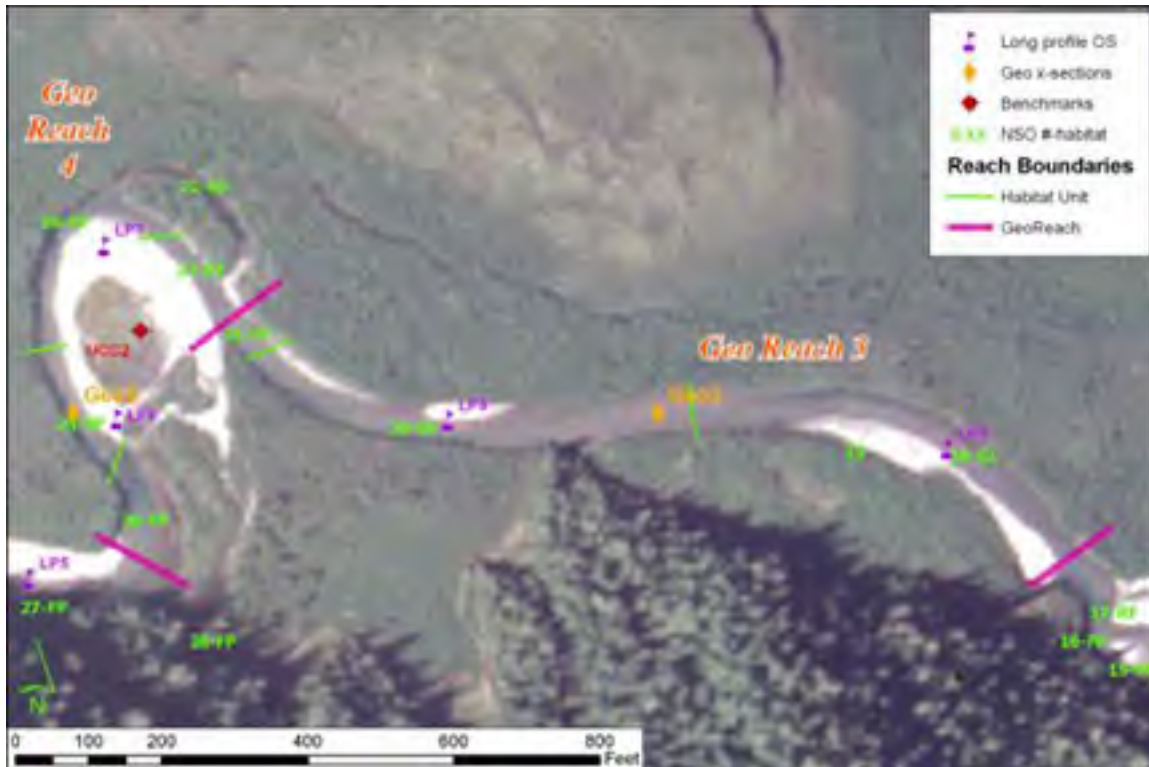
Figure 2-1b: Geo-Reaches 3 and 4 in Upper Cascade Creek.

Geo-Reach 4 was also entirely alluvial, encompassing the single largest meander bend of the study area. This bend had a tight radius of curvature resulting in both an extensive point bar deposit and several neck cutoff channels that have degraded the point bar but not yet led to its abandonment (i.e., the majority of low to moderate flows continue to follow a sinuous course around it). The cross-section was located just past the downstream end of the point-bar sediments, analogous to the location of the cross-section in Reach 2. The bottom of this reach was defined by the return of the channel against the bedrock of the south valley wall, constraining further development of its prior sinuous pattern. This reach starts at NSO 23 and proceeded downstream to the end of NSO 26. NSO 22, also nested within this reach, was a relict side channel with an outlet to the main channel but with no direct upstream inlet connection to the main channel.

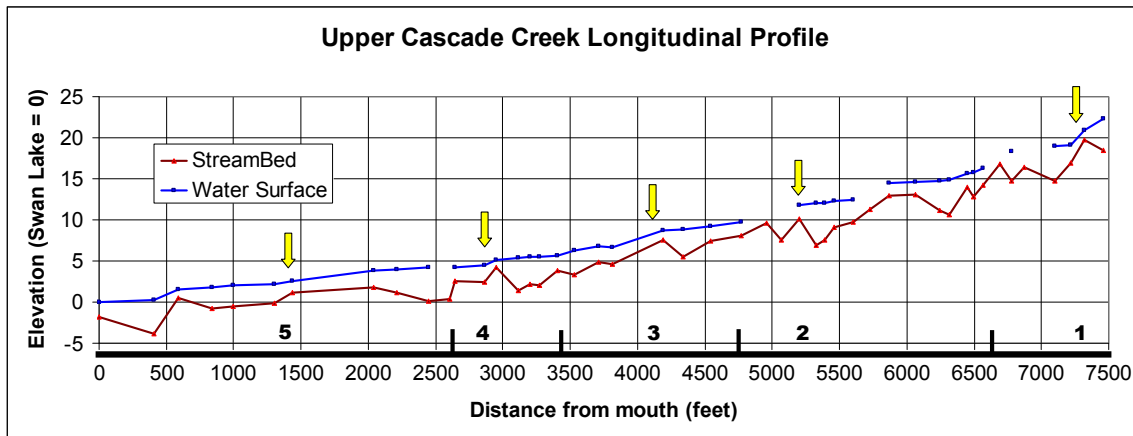
The longitudinal profile of Cascade Creek exhibited a generally concave-up profile of the channel (Figure 2-2). The bed topography was entirely alluvial (i.e., no bare bedrock was observed) and was developed almost entirely as a result of either forced (i.e., impingement of flow against the bedrock valley wall) or free (fully unconstrained) meanders. Boulders and large woody debris were almost entirely absent, providing minimal opportunities for more localized bed heterogeneity.

Figure 2-2: Longitudinal profile of Upper Cascade Creek.

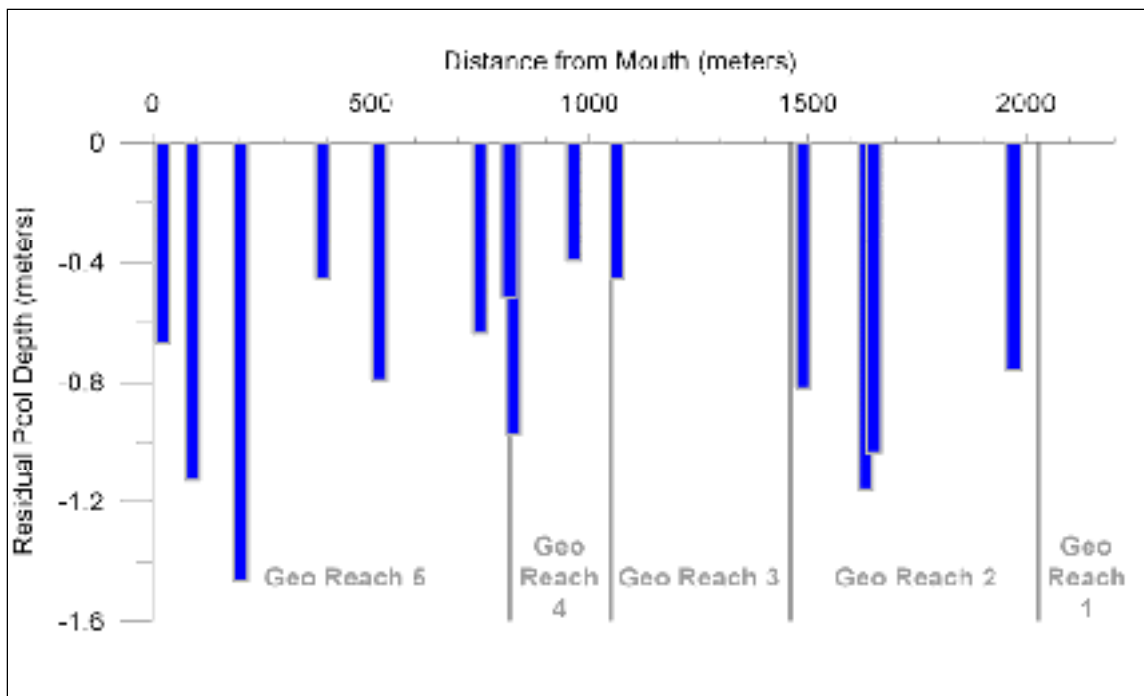
Figure 2-6: Residual pool depths for 5 Geo-Reaches in Upper Cascade Creek.

Residual pool depth (RPD), measured for each pool encountered, was stratified in the sequential Geo-Reaches. Pools were reasonably well distributed across the five Geo-reaches and within individual Geo-reaches (Figure 2-6). RPDs generally exceeded 0.4 m. Determination of RPD was often ambiguous given the nature of the bottom topography that yielded a gradually sloping outlet to pools associated with glides.

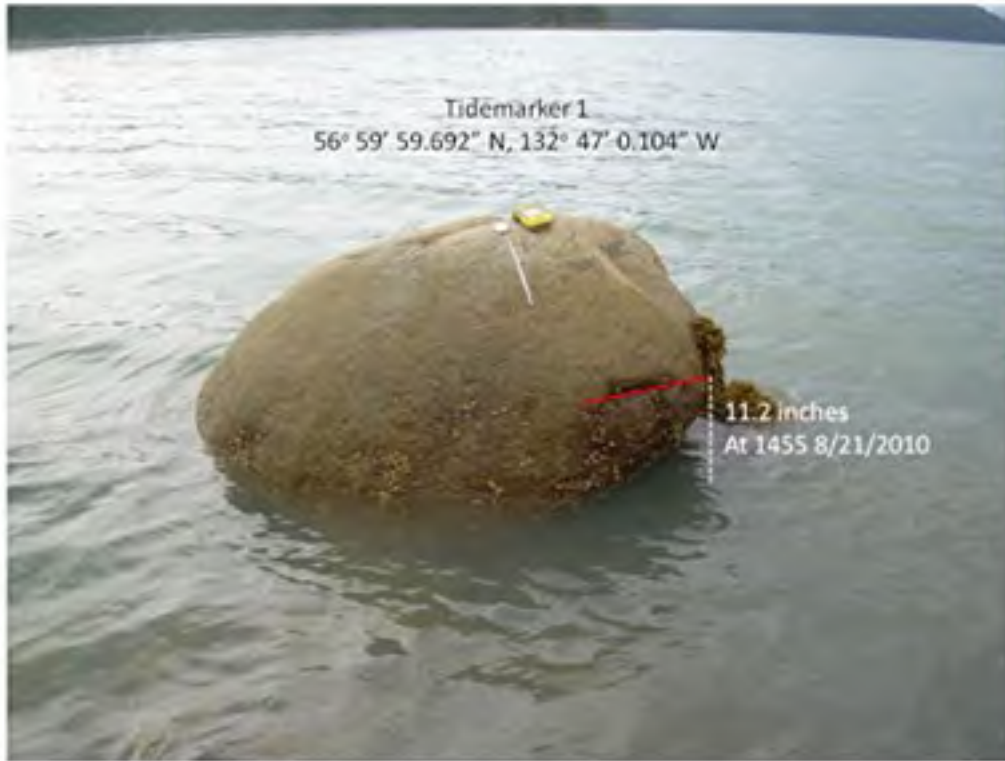
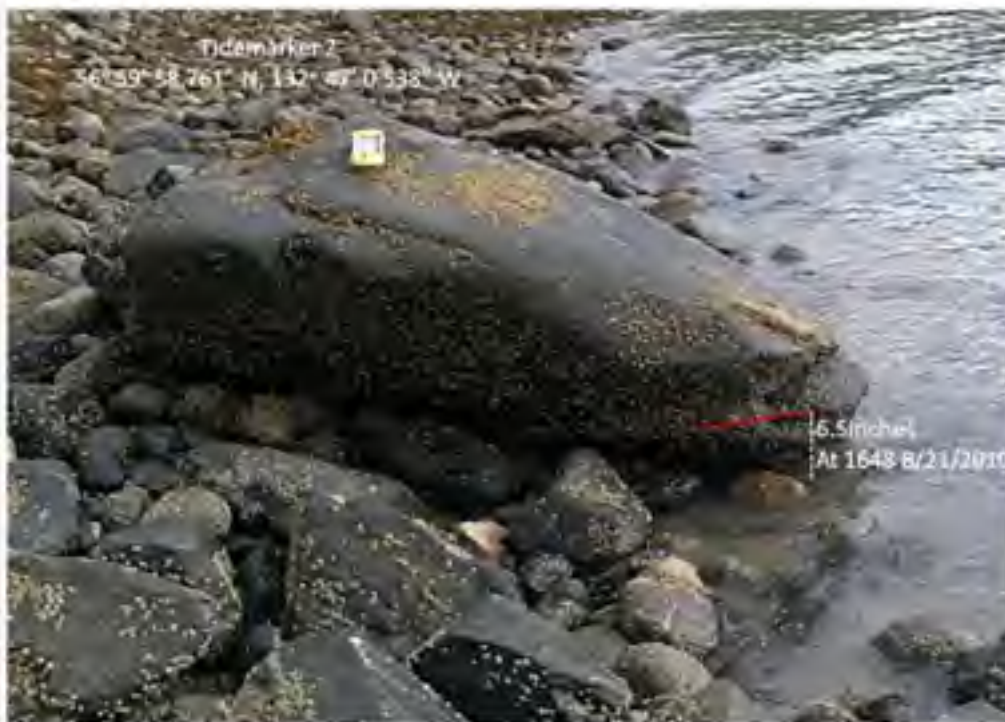
Photo 3-1: Benchmarks used to quantify elevation differences in tide during survey

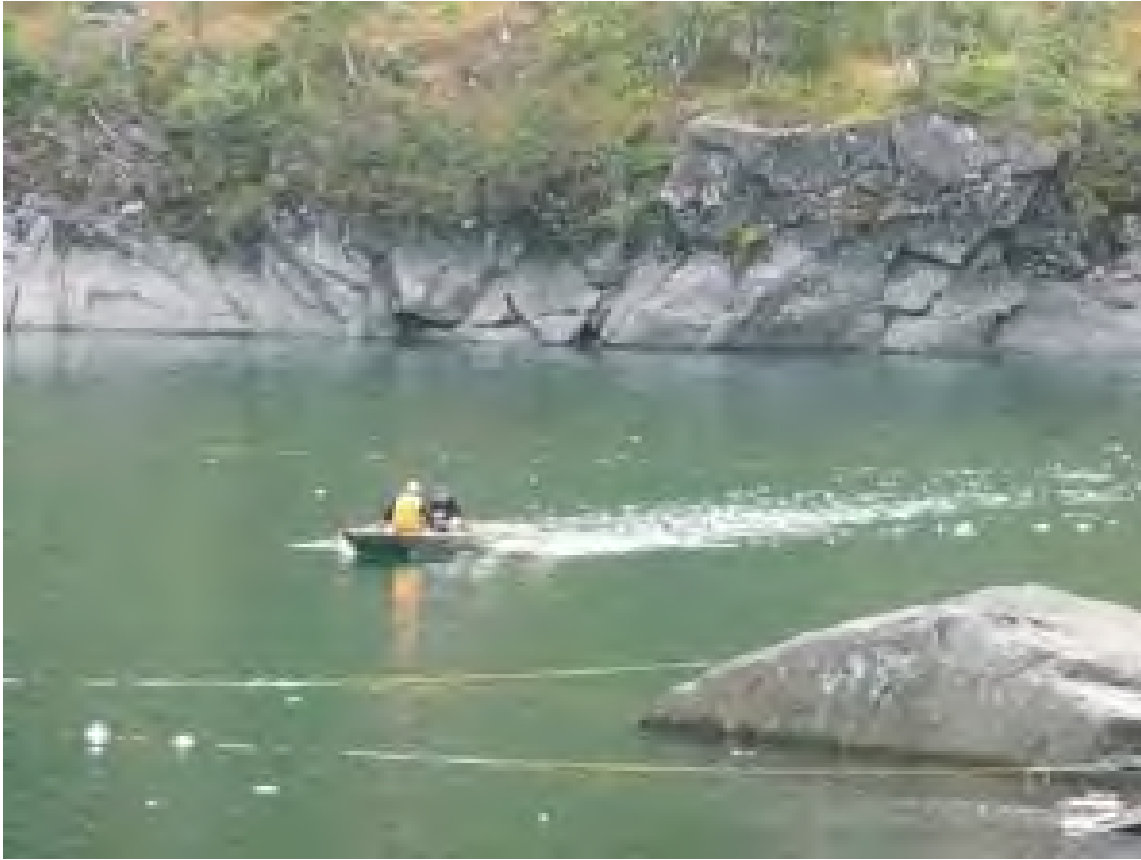
Photo 5-1: Hoop net deployment in Upper Falls Lake, September 2010.

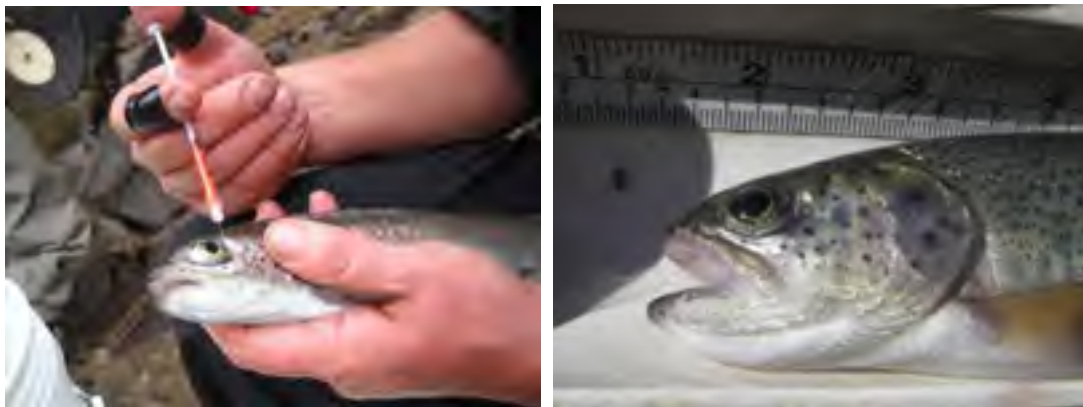
Photo 5-2: Typical rainbow trout marked with visual implant elastomer (VIE).

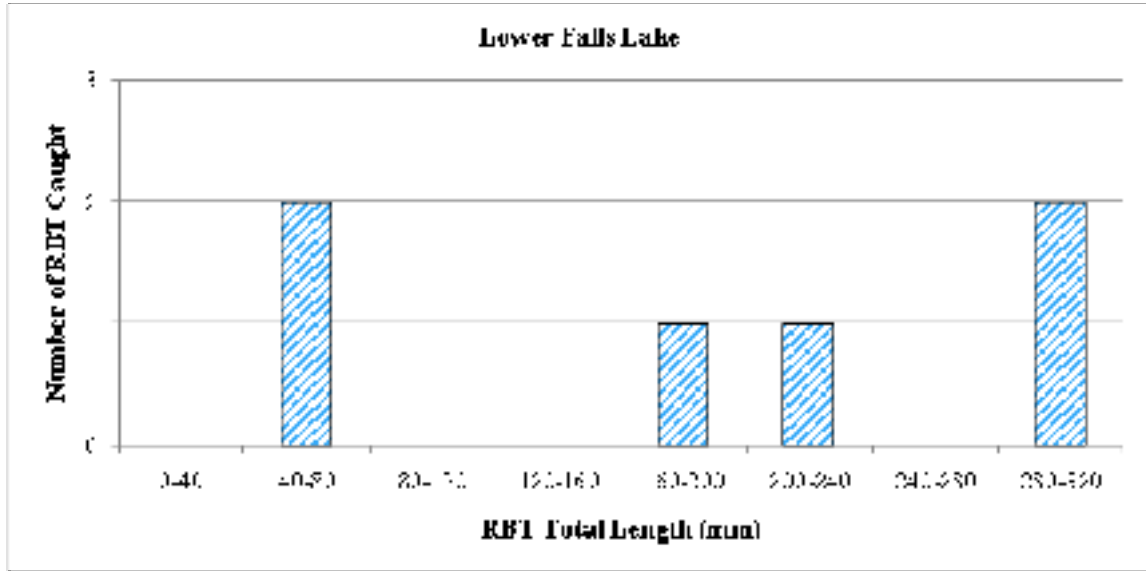
Figure 5-7: RBT length-frequency histogram, Lower Falls Lake, Sep. 2010.

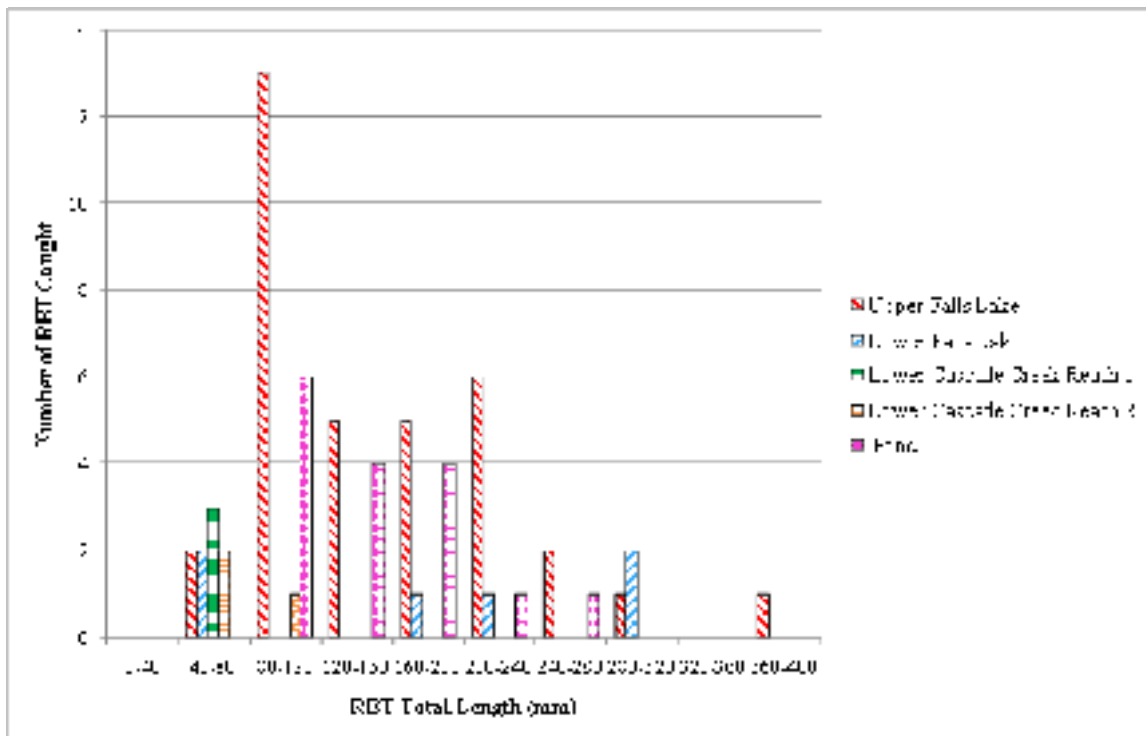
Figure 5-9: Comparative length-frequency of all RBT collected in 2010.

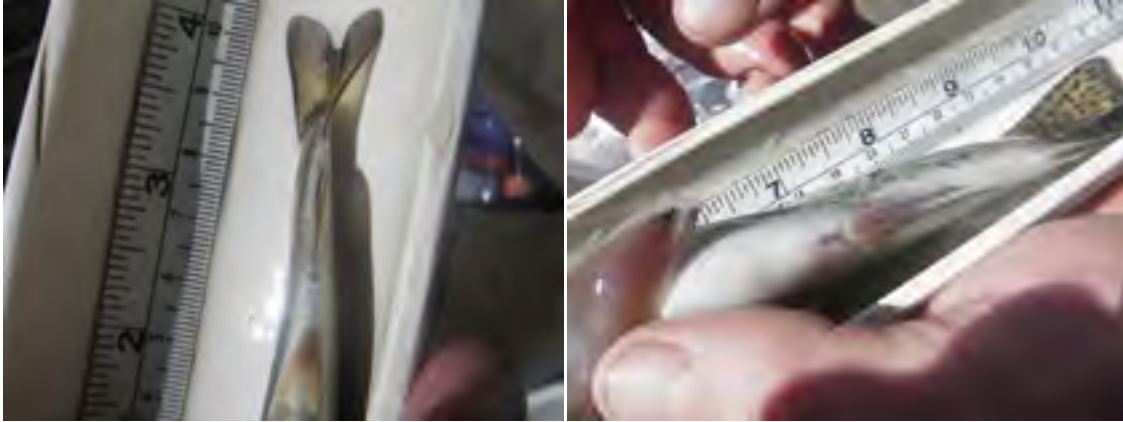
Photo 5-3: RBT with ellipsoid-shaped vent on left; keyhole-shaped vent on right.

shaped vent (n=21) were possible females and RBT with ellipsoid-shaped vents (n=28) were possible males but no effort was made to verify this through destructive sampling.

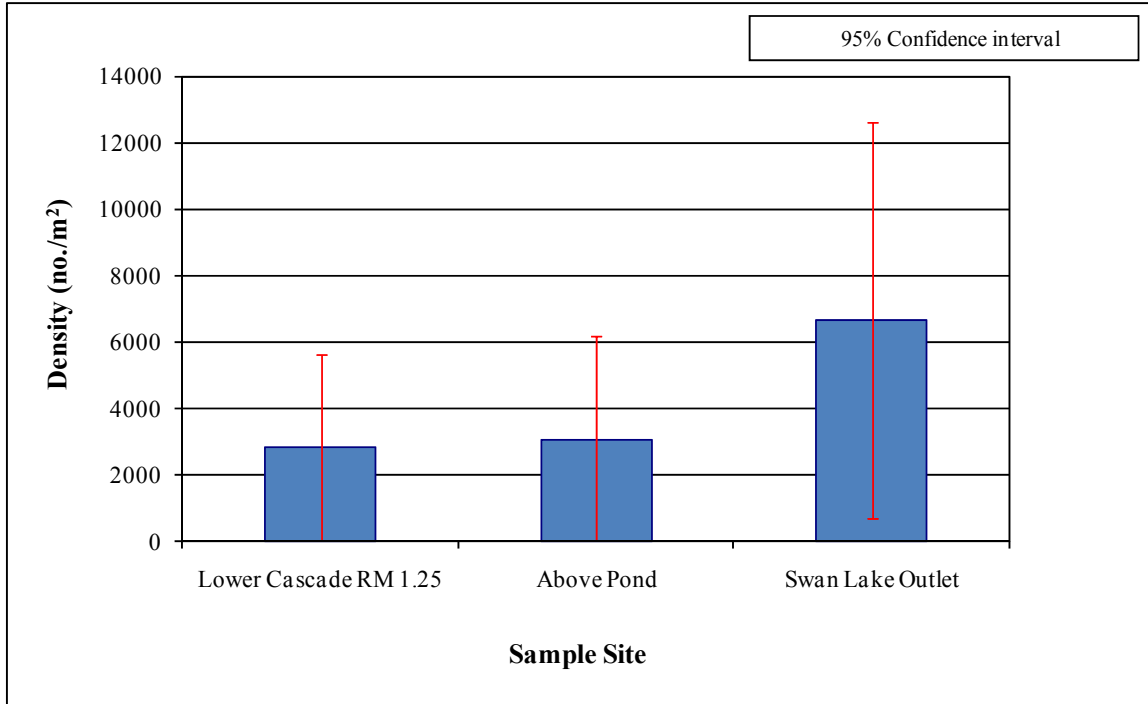
The average BMI density at Swan Lake outlet was double the density observed above the Pond and at Lower Cascade Creek RM 1.25; 6,677 orgs/m² compared to 3,059 and 2,867 orgs/m² respectively (Figure 6-2). The average *Ephemeroptera-Plecoptera-Trichoptera* (EPT) density was also substantially greater at Swan Lake outlet (4,288 orgs/m²) compared to Lower Cascade RM1.25 (1,683 orgs/m²) and the site above the Pond (628 orgs/m²). Despite the density differences between sites EPT comprised 63.5% and 62.0% of the BMI community composition at Swan Lake outlet and Lower Cascade Creek RM 1.25 respectively (Table 6-1). In contrast, EPT comprised only 19.8% at the site above the Pond.

Figure 6-2: BMI density at three sites on Lower Cascade Creek

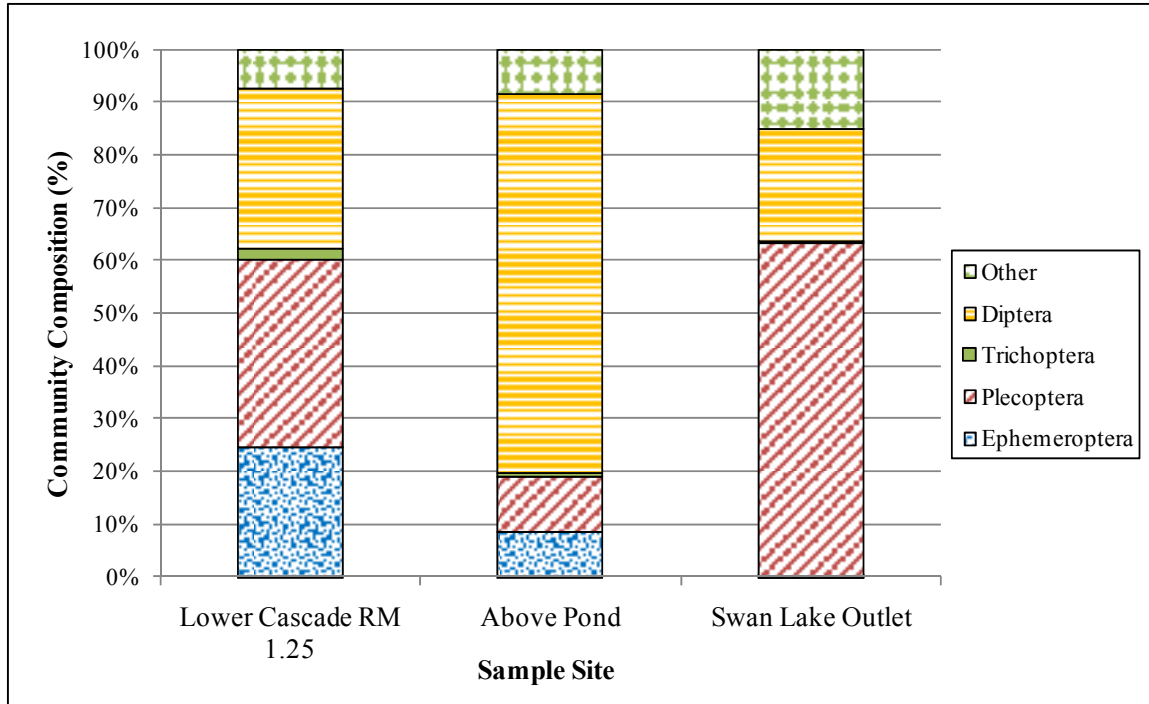
At site BMI3, located above the Pond, *Diptera* comprised the largest percentage of the community composition (71.8%) of which *chironomidae* comprised 68.6%. The dominant taxon was *Eukiefferiella sp.*, a chironomid, comprising 34.7% of the BMI community. *Plecoptera* and *Ephemeroptera* were the second and third largest groups, 10.4% and 8.5% respectively.

Figure 6-3: BMI community composition at three sites on Lower Cascade Creek

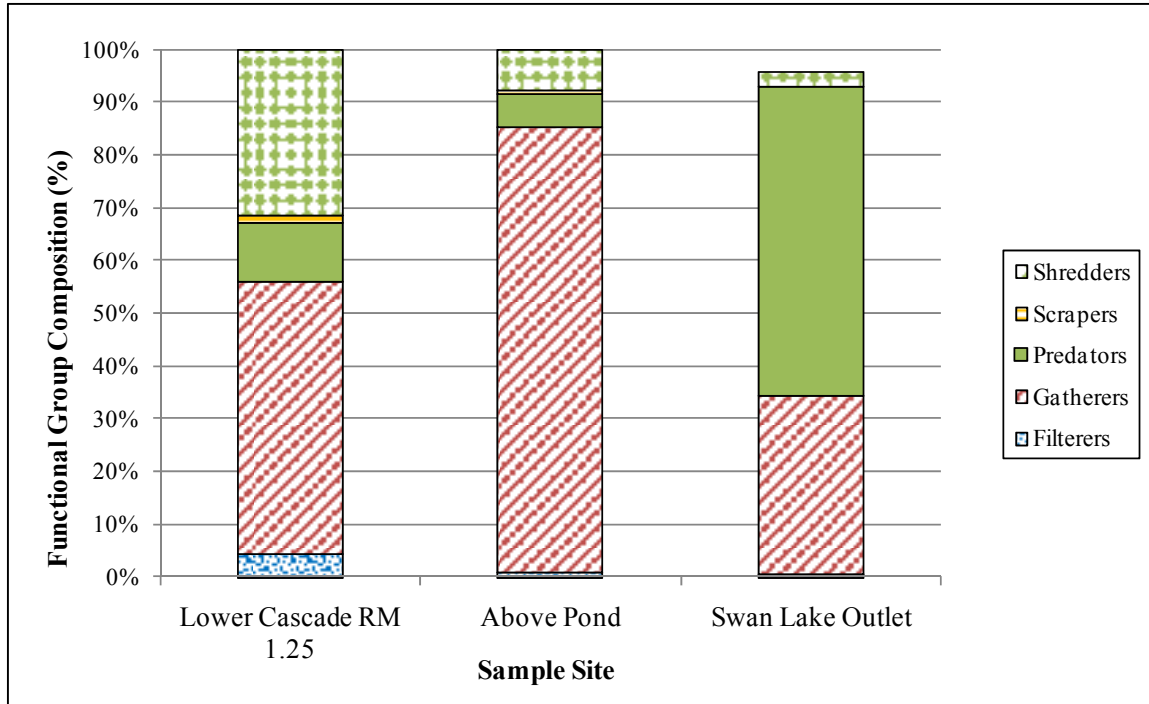
Figure 6-5: BMI functional feeding group composition on Lower Cascade Creek

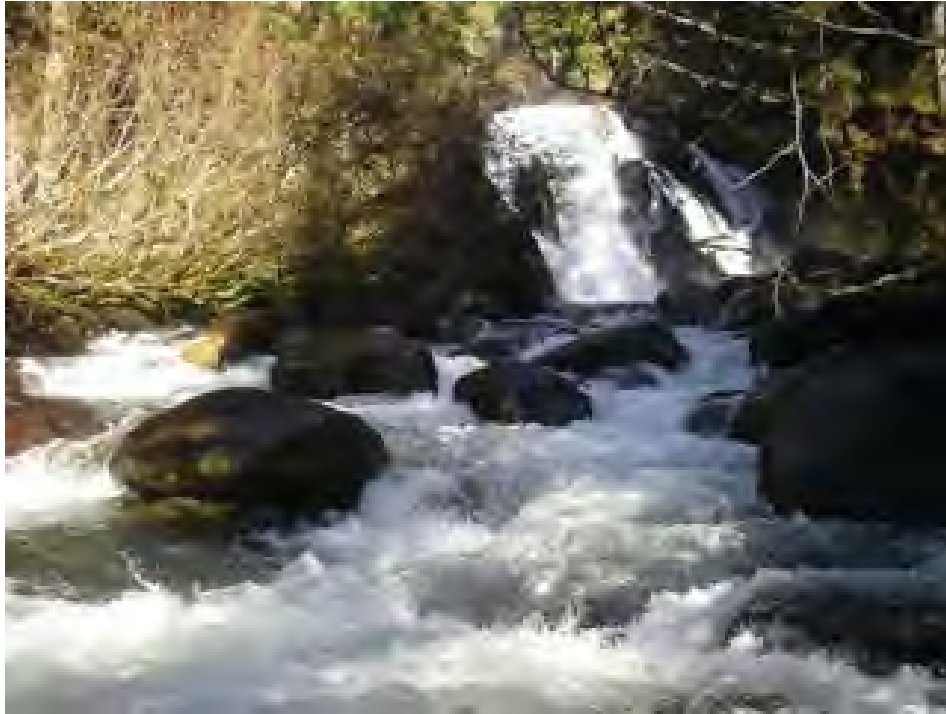
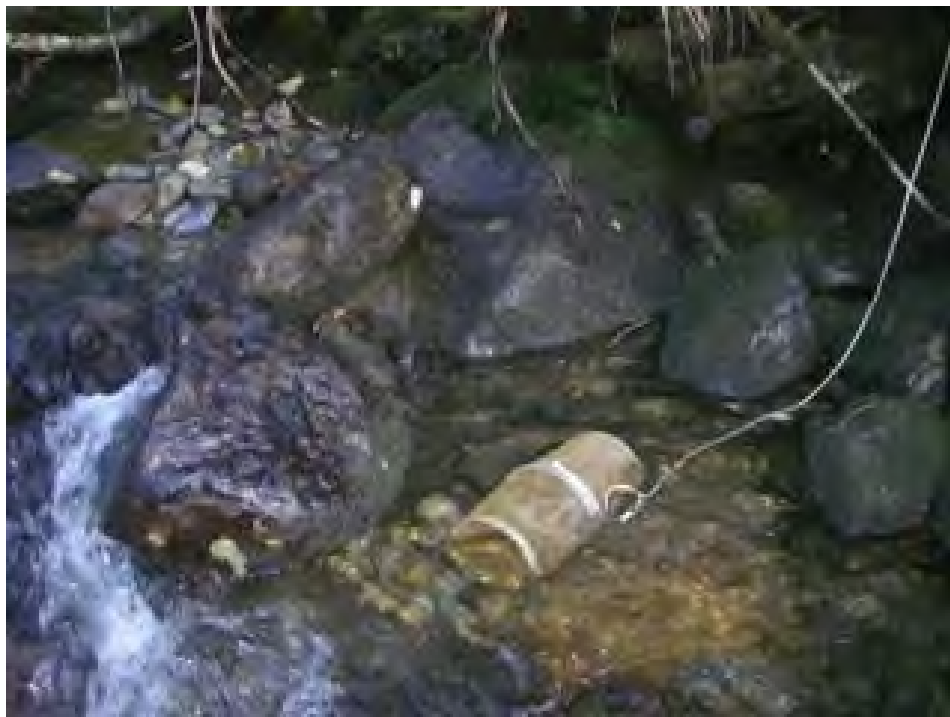
Photos 3 and 4: Barrier falls and upstream view of Reach 1A showing steep gradient and large substrate in main flow/current (top photo) and minnow trap location 1A-7M showing stream substrate along banks of this reach.

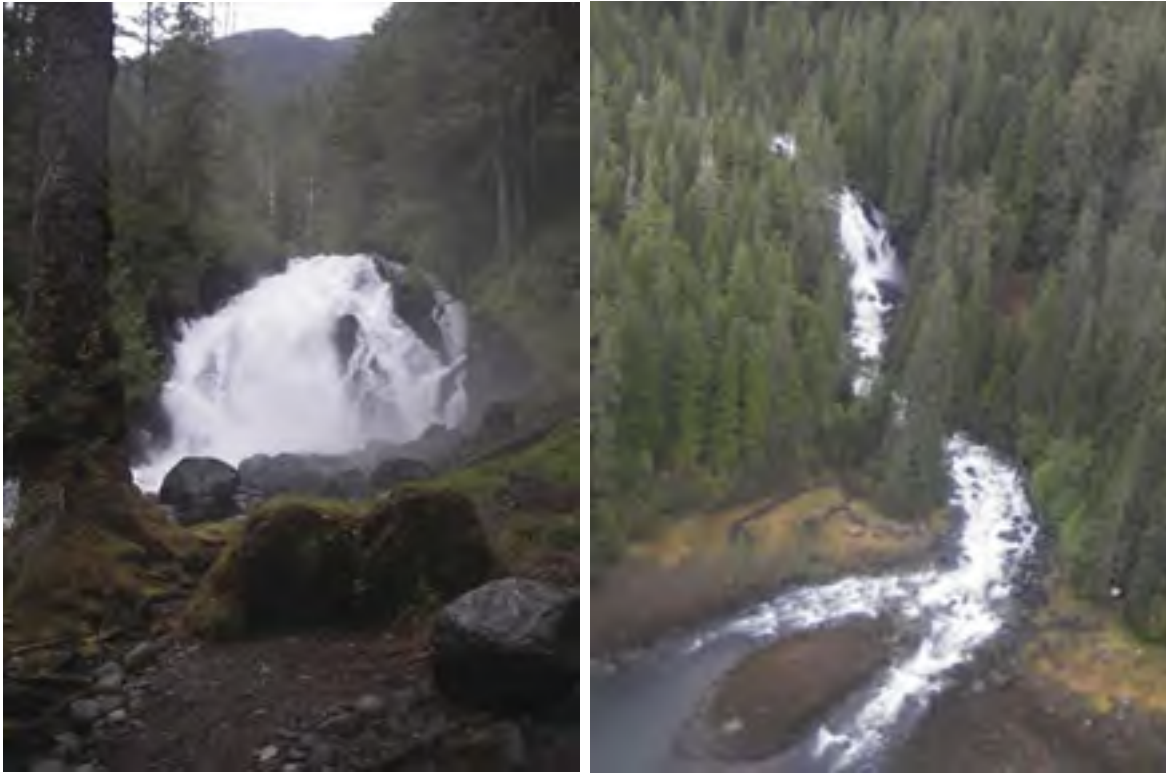
Photo 5-1.1: Upstream Fish Barrier B-1, also known as Cascade Creek Falls, located 150 meters upstream from Thomas Bay, Reach 1A. Photo Date: 10/26/2010 and 9/26/2010 respectively; Discharge was 302 cfs on 10/22/2010 and 438 cfs on 9/26/2010 at the Lower Cascade Creek gauge.

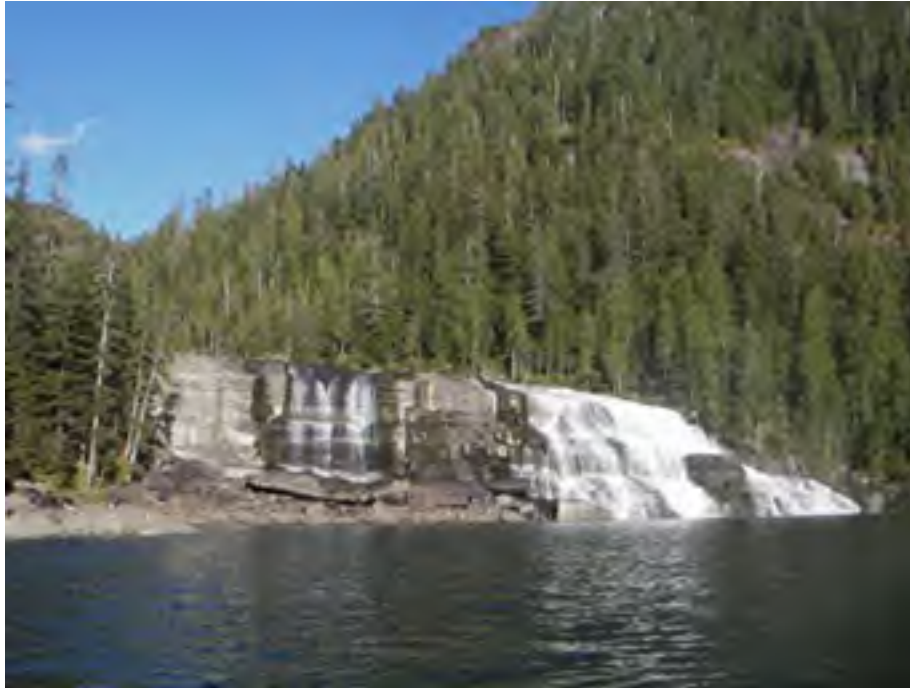
Photo 5-1.3: Barrier B-4 located at Falls Lake inlet in Reach 2A. Photo Date 9/21/2010 and 9/23/2010; Discharge 72 cfs on 9/21/2010 and 63 cfs on 9/23/2010 at the Swan Lake outlet gauge.

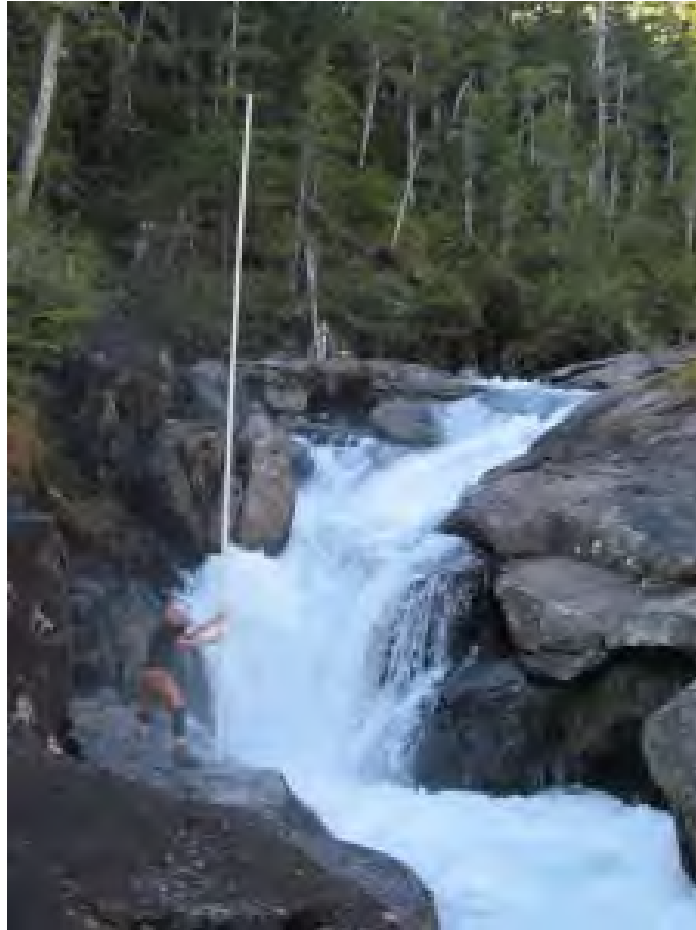
Photo 5-1.4: Barrier B-5 located in Reach 2A directly upstream of lean-to structure. Elevation difference surveyed on 9/21/2010. Photo Date: 9/21/2010; Discharge 72 cfs at the Swan Lake outlet gauge.

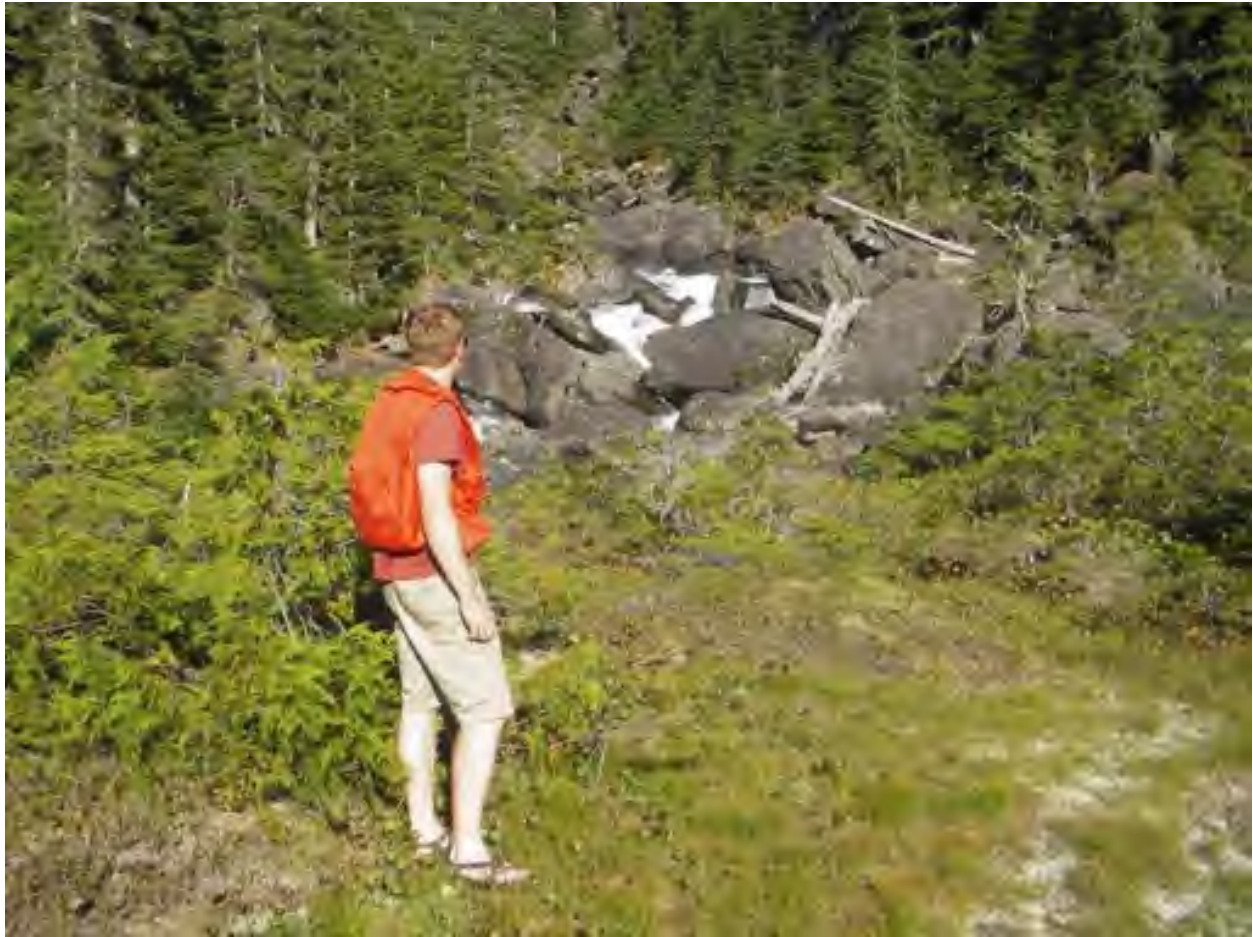
Photo 5-1.6: Potential barrier PB-7 located equidistant between the Pond and Swan Lake outlet in Reach 2B. Boulder cascade with multiple 1.5 to 3 meter drops over 100 meter section. Photo Date: 8/14/2010; Discharge 238 cfs at the Swan Lake outlet gauge.

Barrier PB-7, located directly upstream of PB-6, was a 300 foot reach of giant boulders with numerous falls ranging in height from 5 to 10 feet. This reach likely presents an upstream barrier to fish passage.

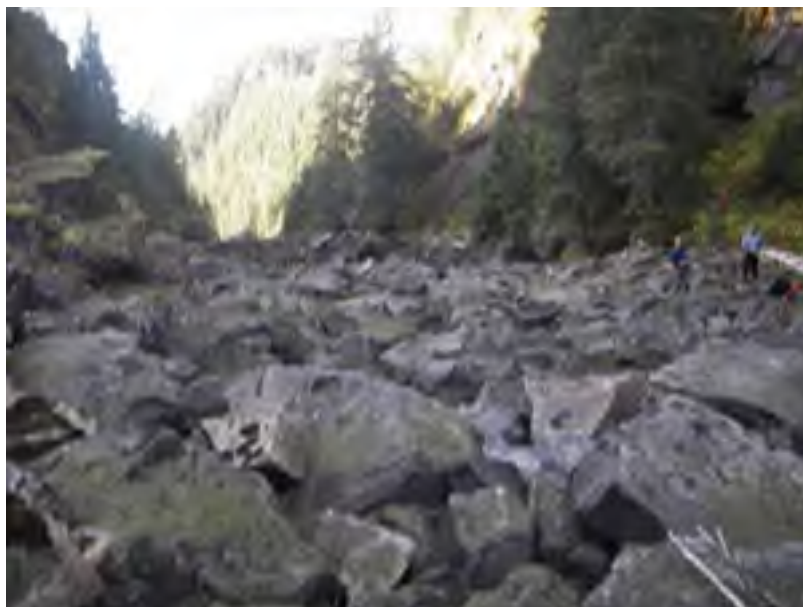
Photo 5-1.8: Middle of potential barrier PB-8 in dewatered section in Reach 2B below Swan Lake outlet. Photo Date: 9/21/2010; Discharge 72 cfs at the Swan Lake outlet gauge (view downstream).

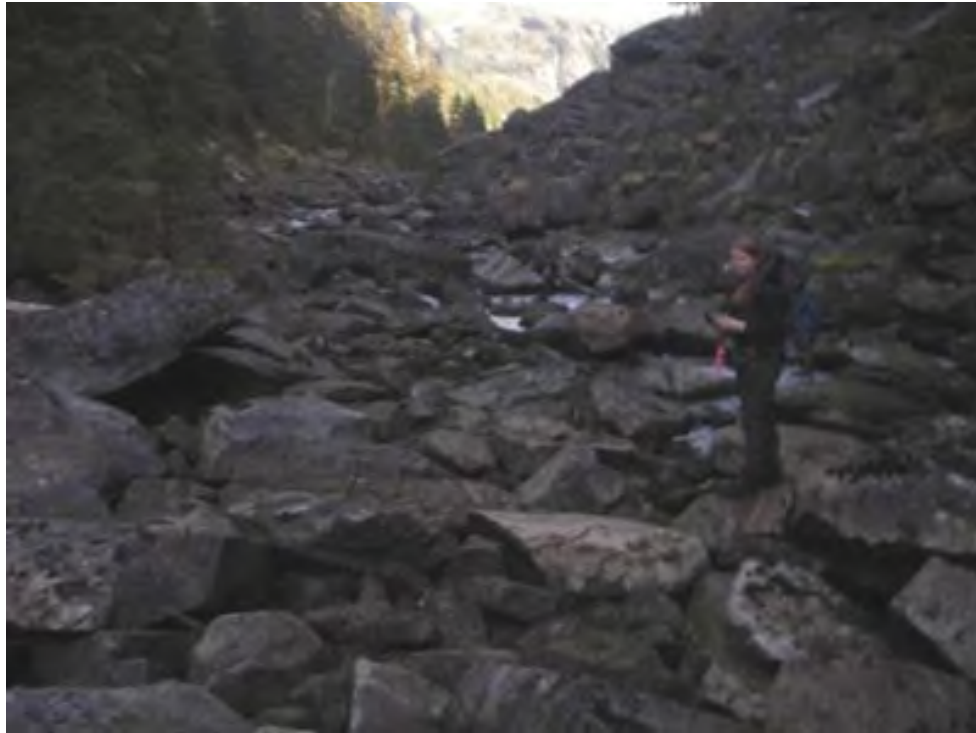
Photo 5-1.9: Start of potential barrier PB-8 in dewatered section in Reach 2B below Swan Lake outlet. Photo Date: 9/21/2010; Discharge 72 cfs at the Swan Lake outlet gauge (view upstream).

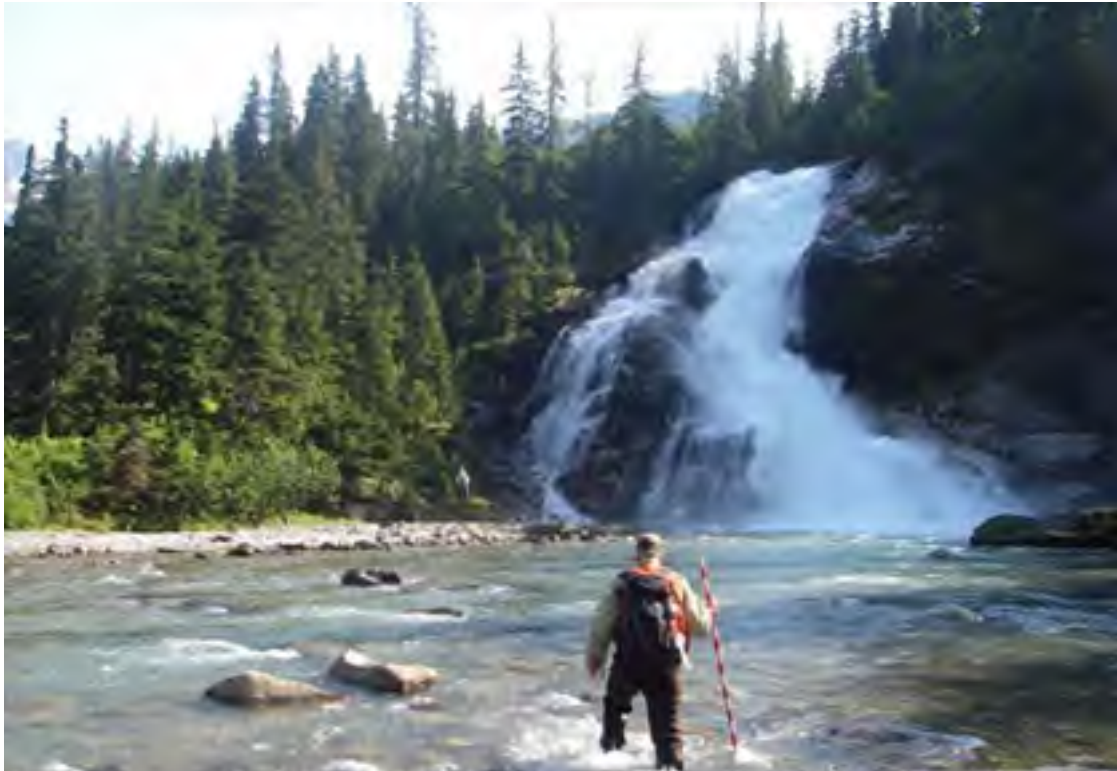
Photo 5-1.10: Barrier B-9 located at the end of Reach 3 in Upper Cascade Creek. Photo Date: 8/15/2010; Discharge 178 cfs at the Swan Lake inlet gauge.
